Project Spotlight

Twintec China

Concrete crack formation in elevated slab forensic analysis

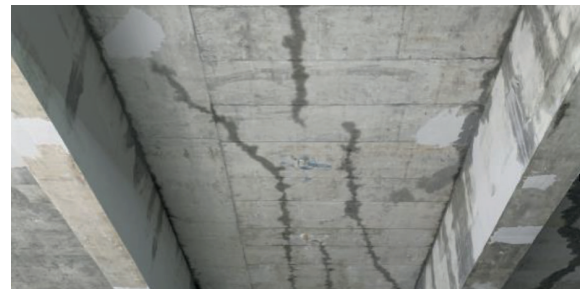
Typical cracking parallel to beam (90%)

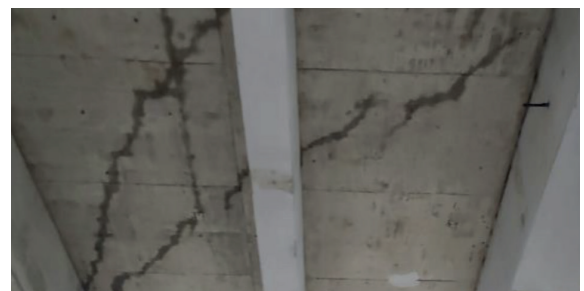
Oblique cracking (5%)

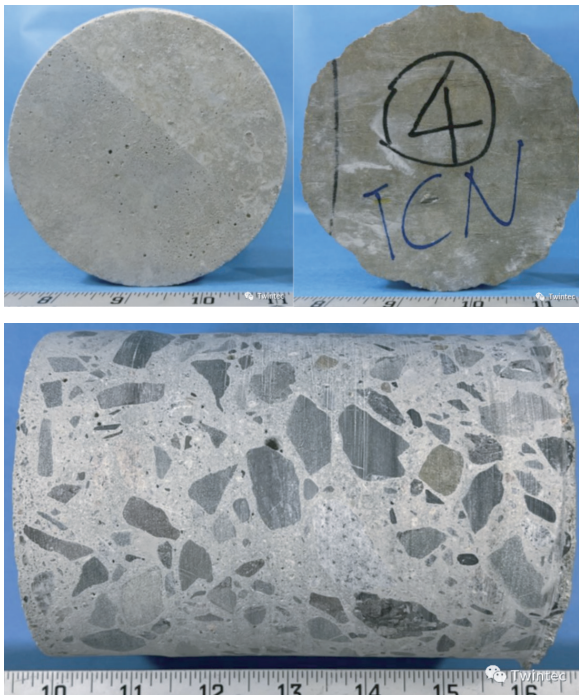
The cores were labeled with the marking "TCN" followed by "Core 4", "Core 5" and "Core 6". (Figure 1 to Figure 3). Core 4 was used as a control sample and did not contain macrocracking (cracks that can be seen with the unaided eye). Cores 5 and 6 contain full-depth cracks.

Figure 1. Core 4. Images of the core as received. The top left image shows the top surface, top right shows the bottom surface, and the bottom image shows a longitudinal view with the top surface to the left.

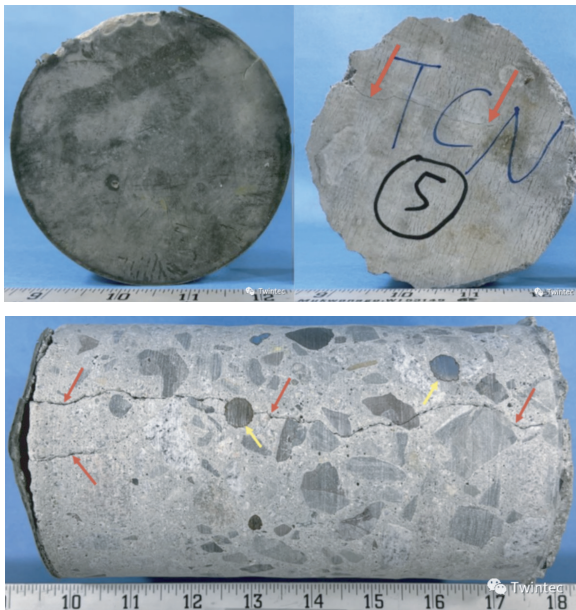
Figure 2 and 3. Core 5. Images of the core as received. The top left image shows the top surface, top right shows the bottom surface, and the bottom image shows a longitudinal view with the top surface to the left. Red arrows indicate partial and full-depth cracking visible along the side and bottom surface. Yellow arrows indicate rebar.

Crack widths on Cores 5 and 6 were measured along the side of the samples in the as-received condition. The main full-depth crack in Core 5 measured approximately 1 mm near the top and narrowed slightly with depth to an average of 0.7mm near the bottom. The full-depth crack in Core 6 was slightly narrower than that in Core 5, measuring on average 0.7 mm near the top and tapering slightly near the bottom. The cracks in both cores were measured on two sides of each core, and measurements were not identical in both locations; the values listed above are approximate averages of both sides.

Both cracks intersected rebar and the crack in Core 6 also intersected a plastic tube. Due to raveling, abrading, and relaxation from coring operation, true crack widths in the field are likely less than those measured in the laboratory examinations.

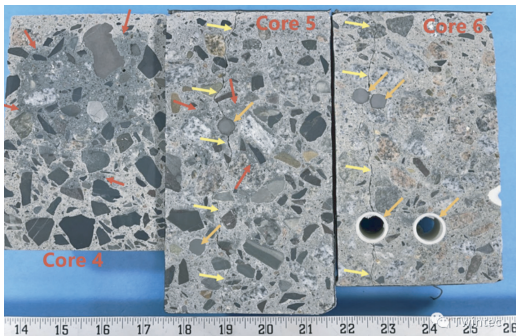
Observation of the core samples shows that Core 4 does not contain major cracks (Figure 1, 4, 5), but Cores 5 and 6 contain a full-depth crack (Figure 2-5, Figure 7-10).

Figure 4. Cores 4, 5 and 6, as marked. Image of the full-depth lapped cross section of each core. Note the bluish color paste near the upper center of Core 4 (red arrows), minor mottled bluish color in Core 5, and minimal blue paste in Core 6, which are all due to presence of slag cement. Yellow arrows indicate full-depth cracking in Cores 5 and 6. Orange arrows indicate embedded steel or plastic tubes.

- c. Cracks in Cores 5 and 6 are consistent with restrained volumetric changes due to drying shrinkage and/or thermal-related volumetric changes. The cracks are not related to deleterious chemical reactions such as ASR or DEF.

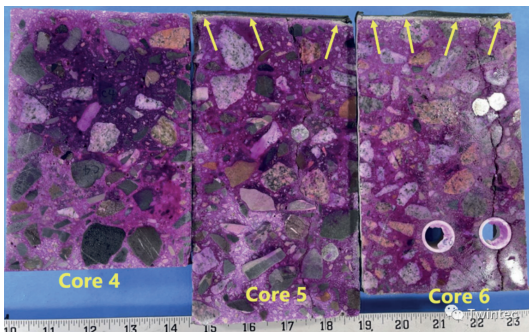
9. The depth of carbonation was less than 0.5 mm in Core 4 and 2-4 mm in Cores 5 and 6 (Figure 5). The carbonated top layer in Cores 5 and 6 was weaker and more absorptive to water droplets than the concrete below the top layer. The carbonated, weak layer appeared to have been caused by elevated w/cm, inadequate curing, or a combination thereof. Elevated water could be due to minor bleeding/segregation or water addition during finishing. No weak layer was observed in Core 4.

- d. Cores 5 and 6 contain a roughly 3 mm (1/8 inch) thick, weaker layer than the body concrete along the top surface. The weak layer was likely caused by elevated w/cm and/or inadequate curing. No weak layer was observed in Core 4.

Figure 5. Cores 4, 5, and 6, as marked. Image of freshly sawn full-depth cross sections of each core shortly after being sprayed with pH-indicating phenolphthalein solution. Note the thin layer of carbonated paste along the top surface of Cores 5 and 6 (yellow arrows), and no visible carbonation on the surface of Core 4.

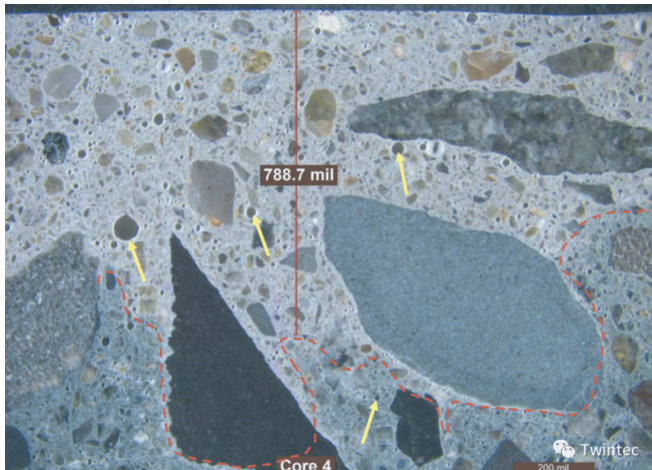
Figure 6. Core 4. Close-up image of the top surface region. The measurement in the center of the image indicates the typical depth at which bluish color paste is present (approximately 788 mils or 20 mm). The bluish paste can be seen in the bottom half of the image (below red dashed lines). The concrete contains many small spherical air voids (yellow arrows).

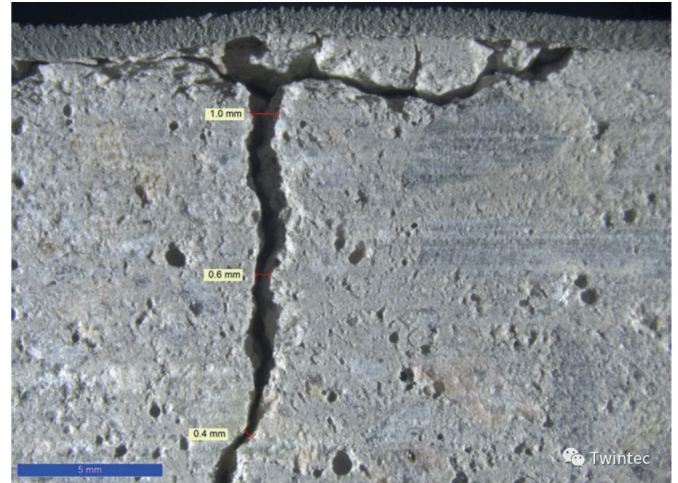
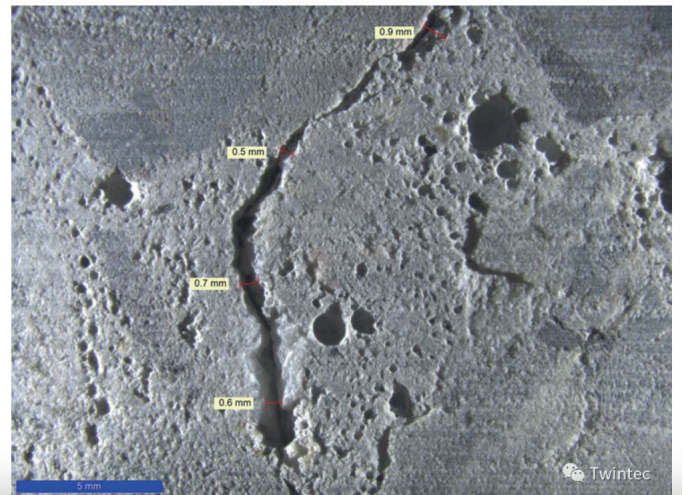
Figure 8. Core 5. Close-up images of the full-depth crack along the as-received core side surface, showing crack width measurements at the top (top image) and bottom (bottom image) of the core. Note that the crack width does not vary much, averaging 0.9 to 1 mm. Due to raveling/abrasing from coring operation, true crack width is likely less than the measured.

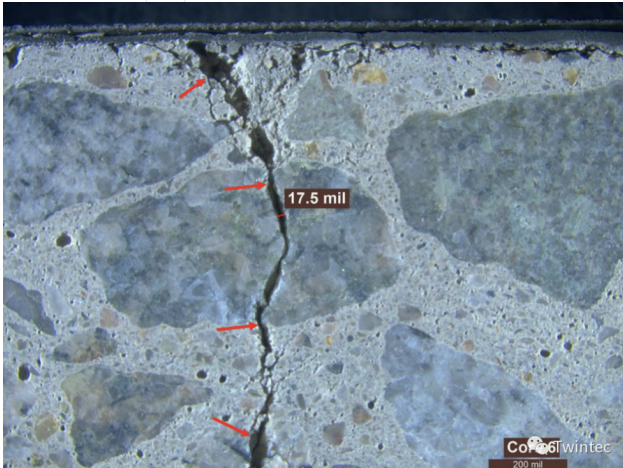
Figure 9. Core 6. Close-up image of the top surface region. The measurement near the center of the image indicates typical crack width along the lapped surface within the top region. Red arrows indicate cracking, which extends the full depth of the sample. The crack propagates through two coarse aggregate particles in this region.

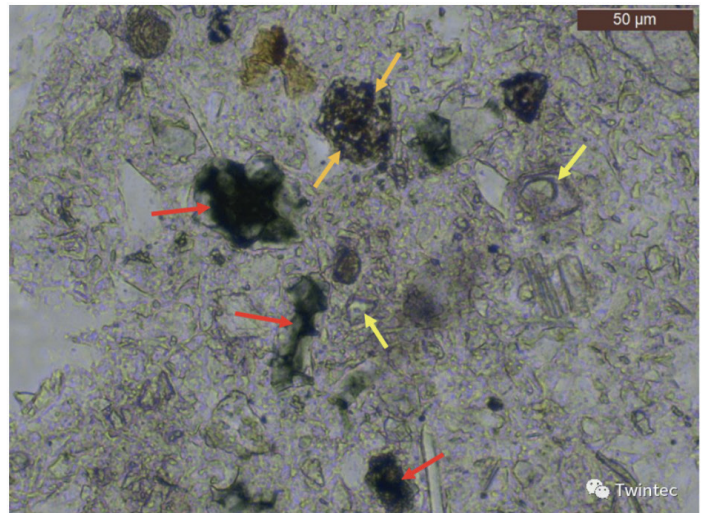
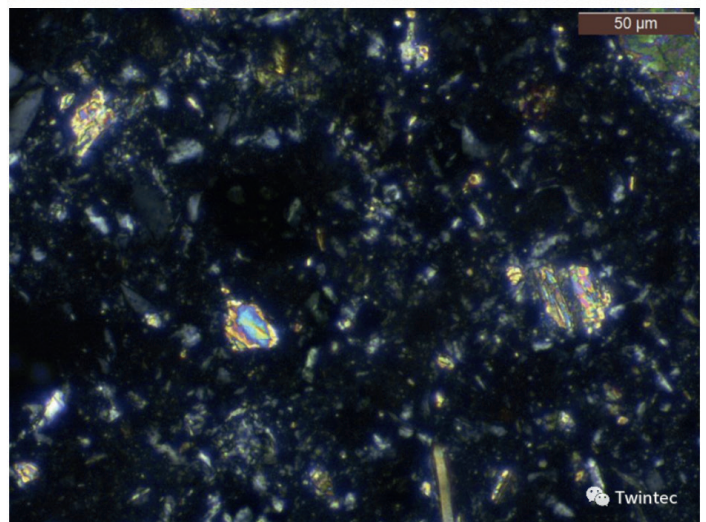
Figure 10 and 11. Core 4. Photographs of paste show Portland cement (red arrows), slag cement (yellow arrows) and suspected specialty cement of the expansive agent (orange arrows). Trace amounts of fly ash were observed (not shown). Note Portland cement was stained green due to presence of slag cement, contributing to the observed blue-green color of the paste. Top image: plane-polarized light. Bottom: cross-polarized light.
